OFFICIAL NORTH CAROLINA WOOD-DESTROYING INSECT INFORMATION REPORT

1. Seller's Name(s)					
	Buyer's Name(s)Clinton Ebadi				
Address of Property 2125 Mariner Cir, Raleigh, NC, 27603-2665					
Structure(s) Inspected: A. Main Residence Onlyx B. Other					
FINDINGS

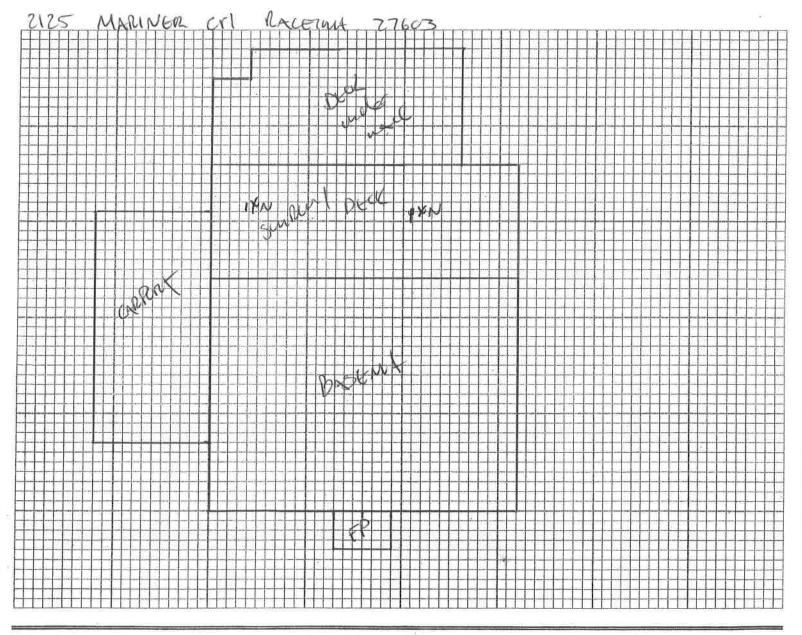
5. The following conditions conducive to subterranean contact under sunroom/deck.	termites were noted on this property: Wood to ground				
IPM: Name Thereits & Dark & Dark	DCO Lie No. 1422 W. D-45				
IRM: Neuse Termite & Pest Control Inc. ddress: P.O. Box 446, Clayton, NC, 27528	PCO Lic No. 1443 PW Date 07/15/2019 Telephone: 919-553-9888				
ignature of Authorized Company Rep: White Tooks urchaser's signature is required on reverse side.	Title: Manager
